## Matthew Jones House

Historic Maintenance and Repair Manual

### **Final report**

Under   Project # 396574, "Matthew Jones House Maintenance & Repair Manual."

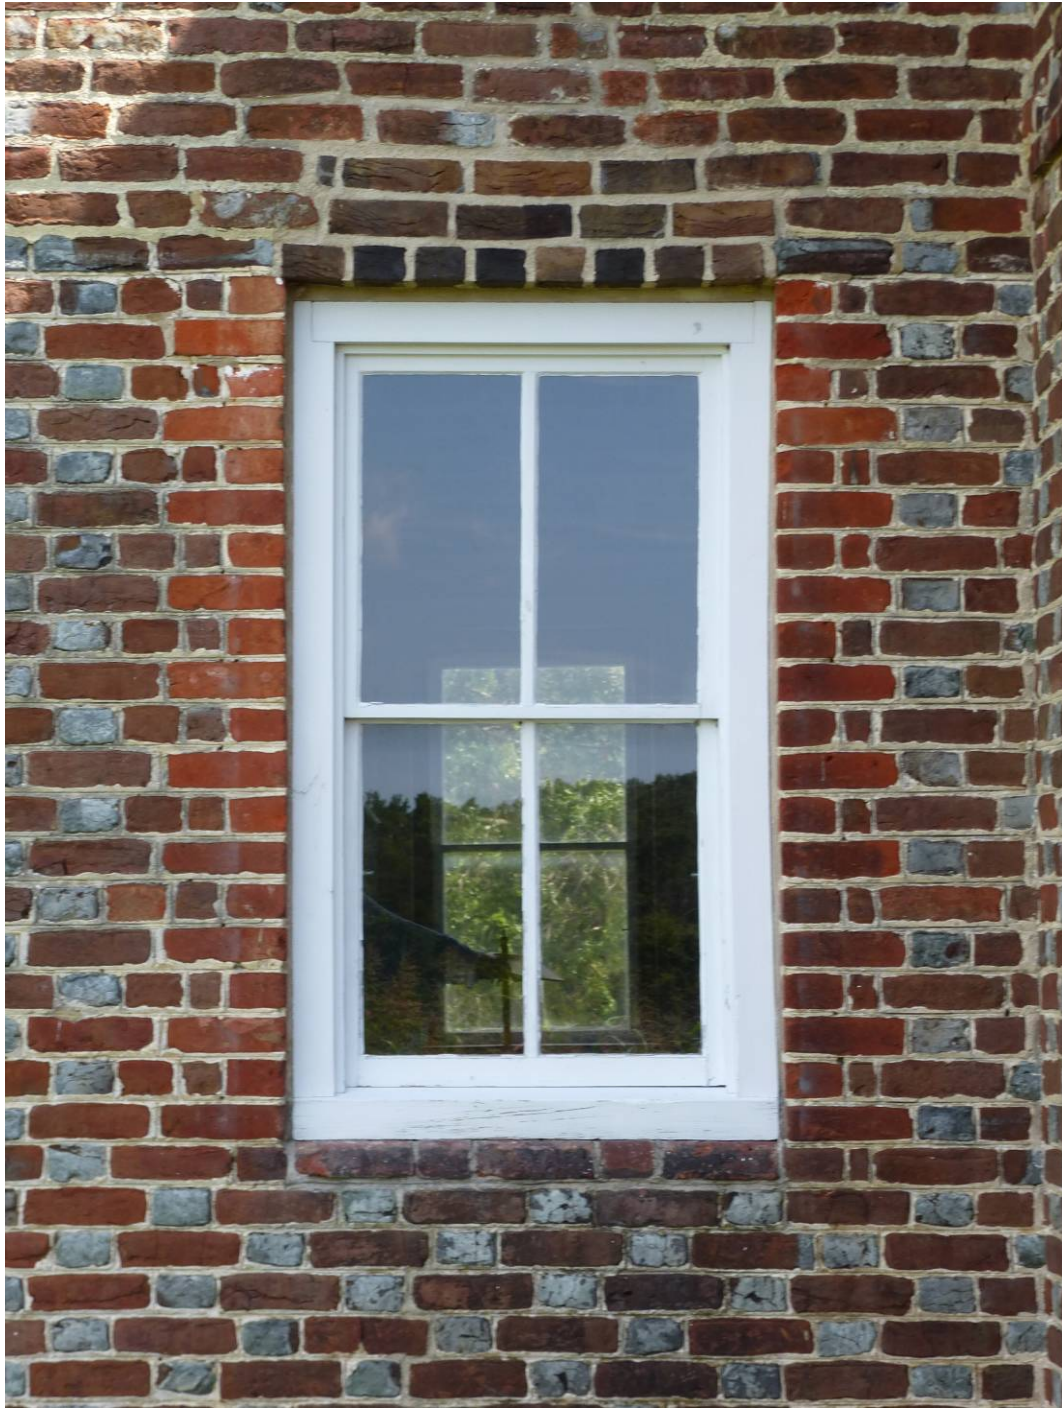
Figure 33. Wood windows on the first floor of the Matthew Jones House need to be replaced with more appropriate Period II windows (ERDC-CERL, 2012).

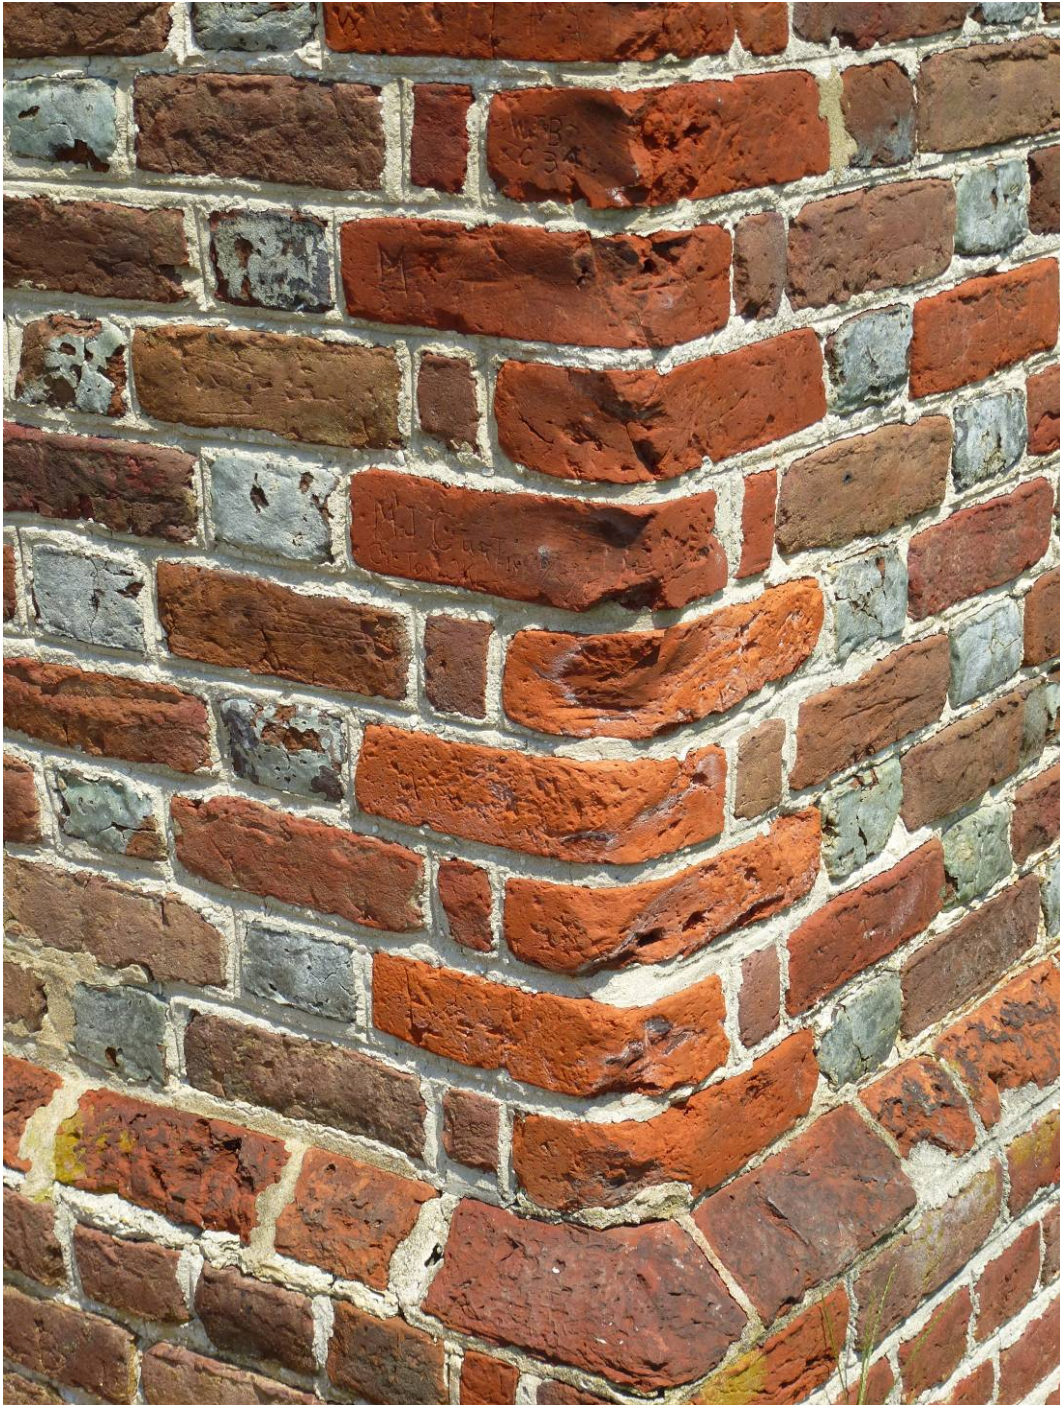
Figure 54. Bright red, rubbed bricks were used on the exterior corners above the water table (including the shed), creating a “quin” effect. These corner bricks are showing signs of pitting (ERDC-CERL, 2012).

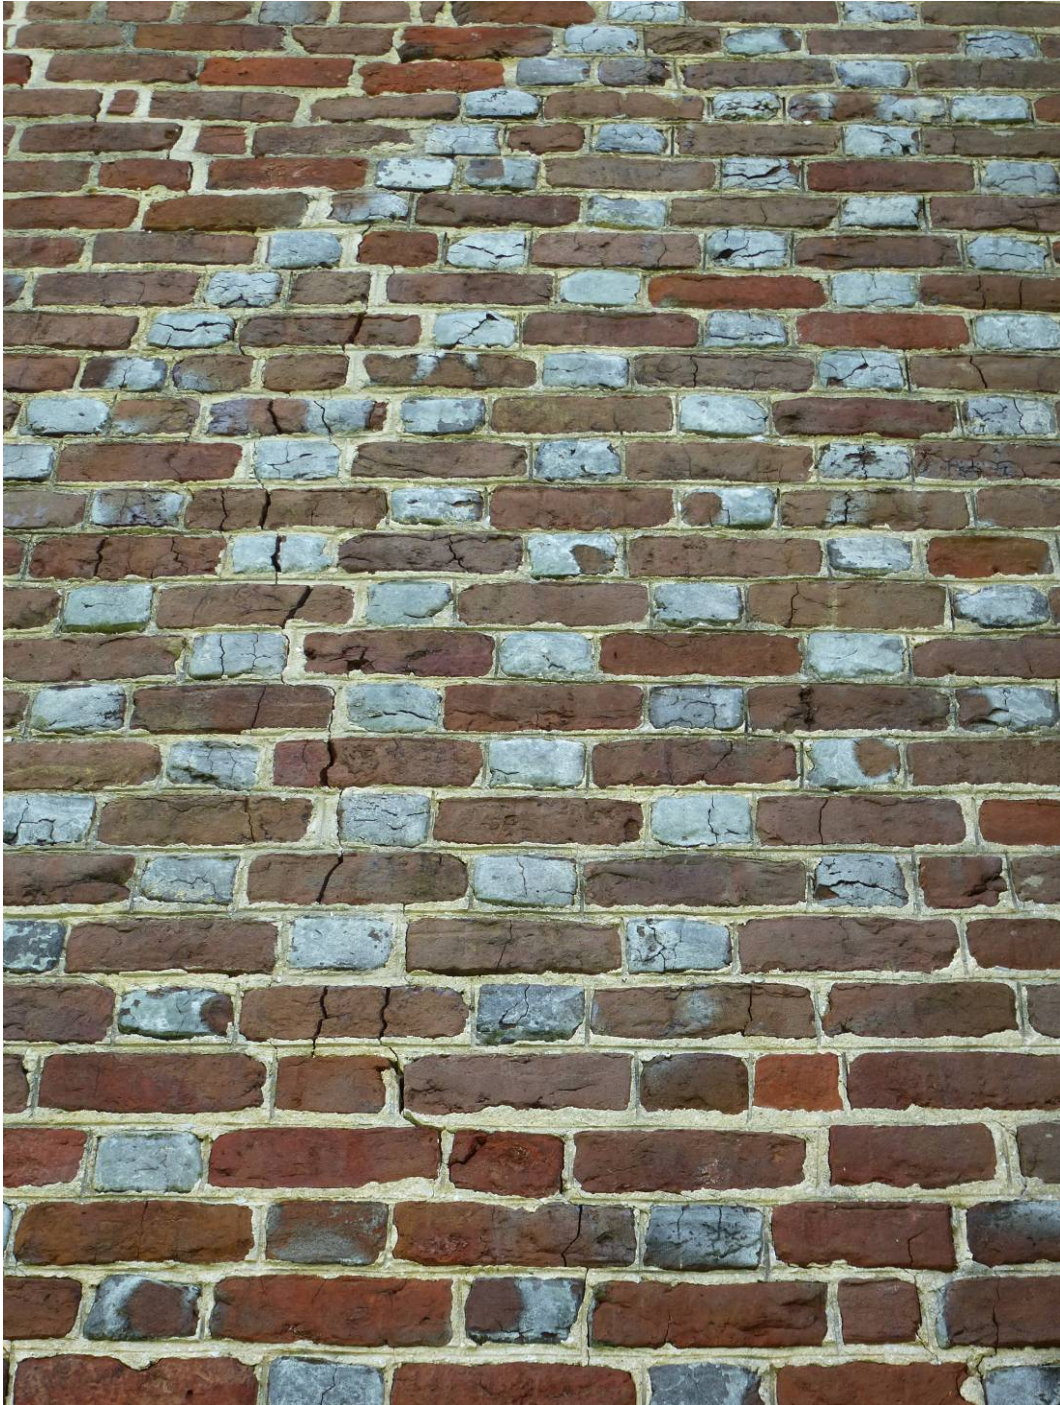
Figure 55. Long vertical crack in the northwest wall (ERDC-CERL, 2012).

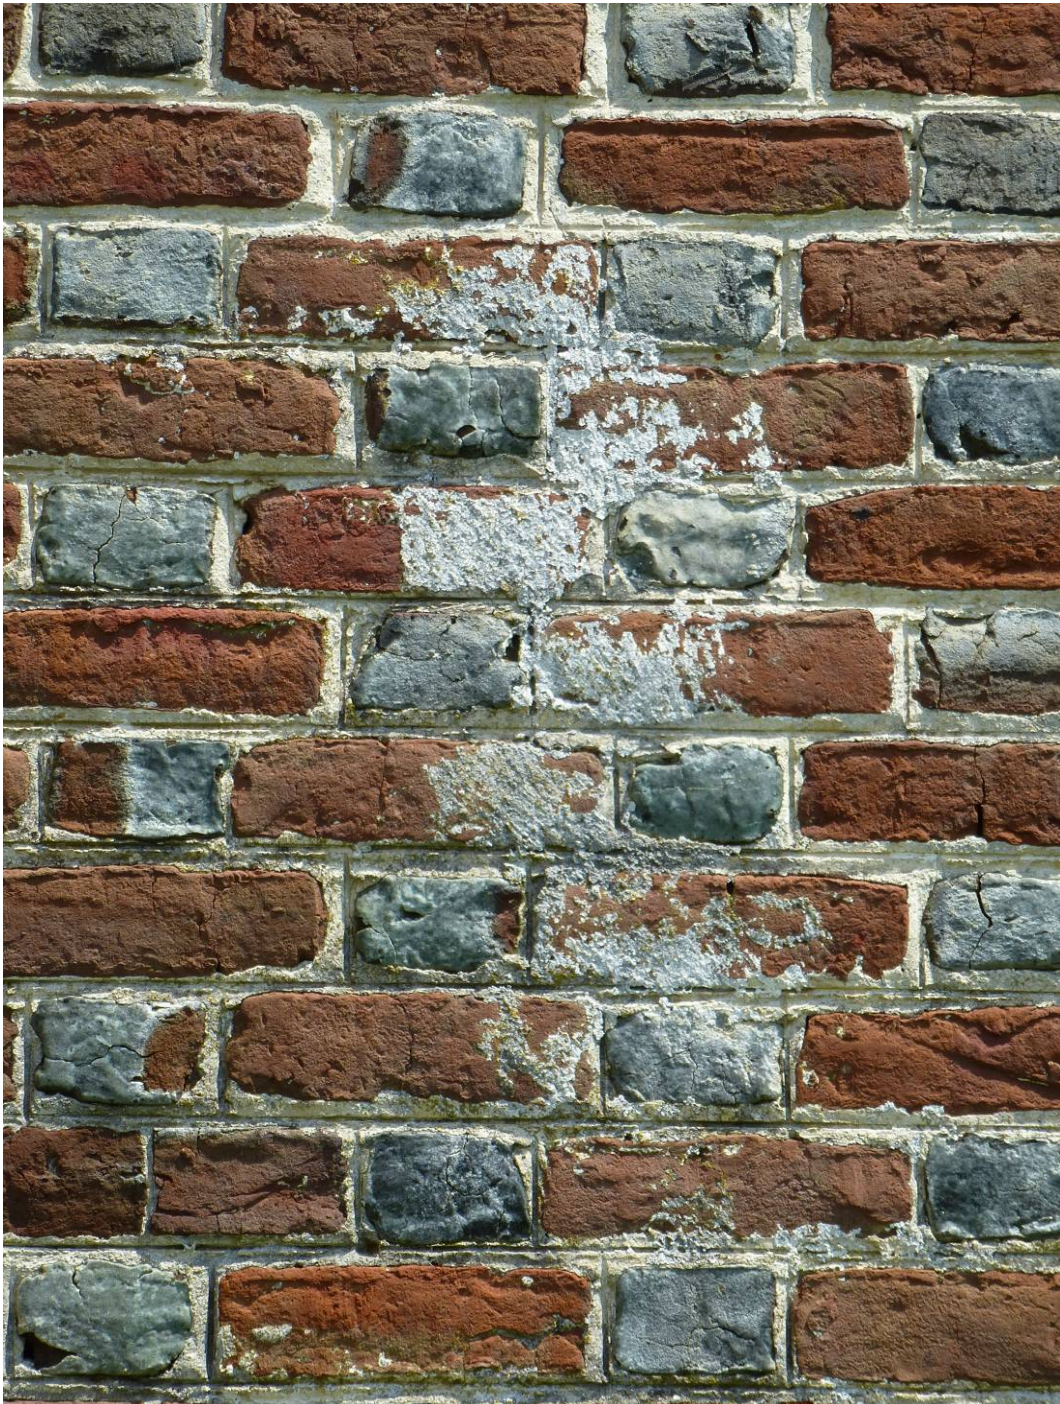
Figure 56. Efflorescence on the brick needs to be removed with a mild cleaning technique (ERDC-CERL, 2012).

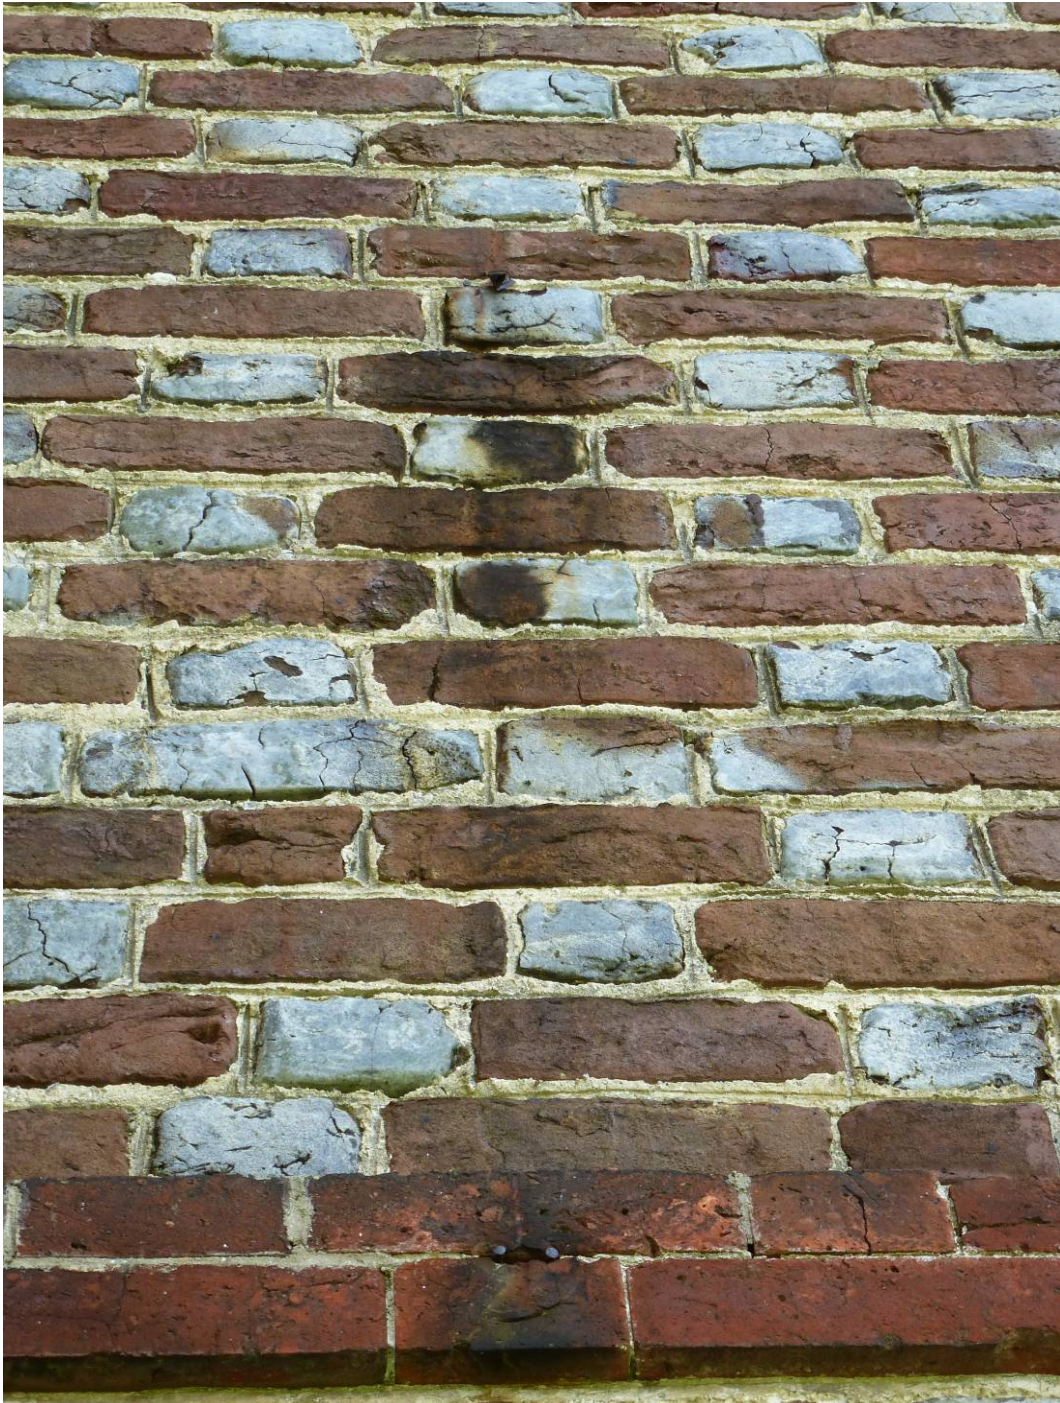
Figure 57. Stains on the brickwork caused by protruding nails should be cleaned according to the *Secretary of Interior Standards for Rehabilitation* (ERDC-CERL, 2012).

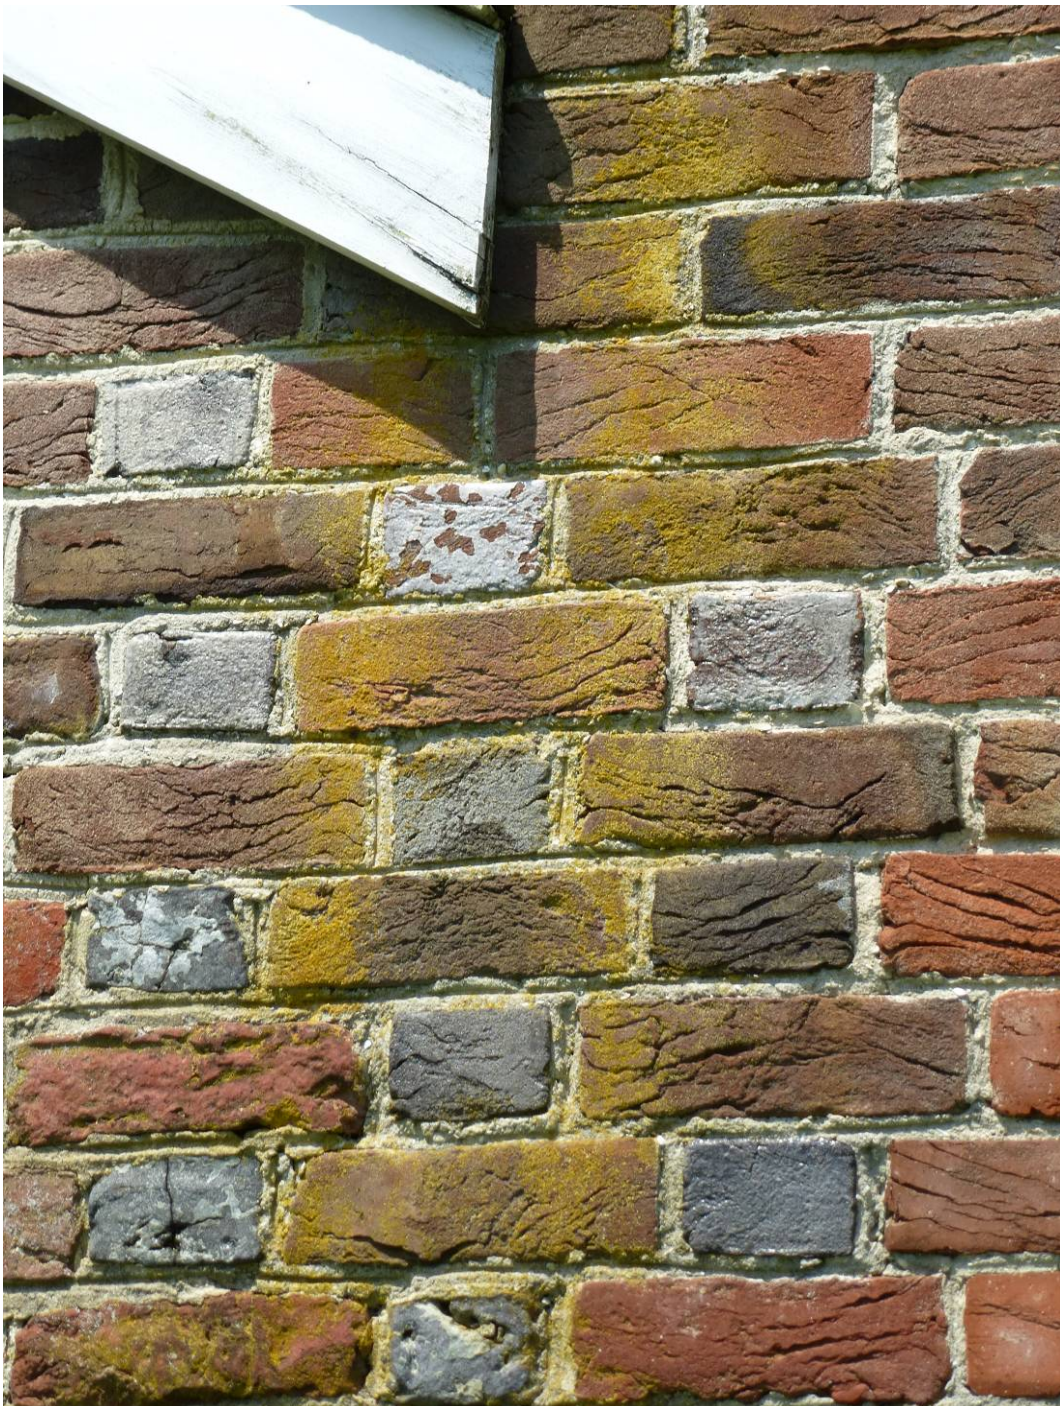
Figure 58. Growth and stains on the brickwork caused by water being shed from wood roof member (ERDC-CERL, 2012).

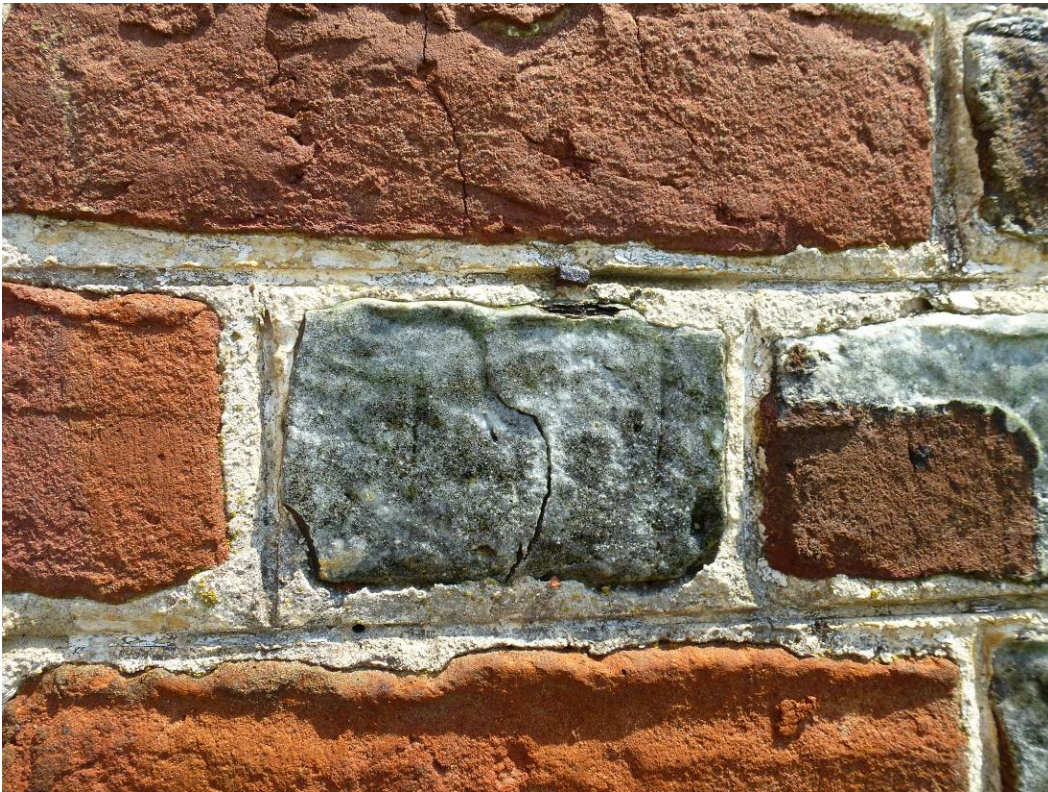
Figure 59. Flaking of the glaze on the brick (center right) is visible on several glazed bricks on the exterior wall (ERDC-CERL, 2012).

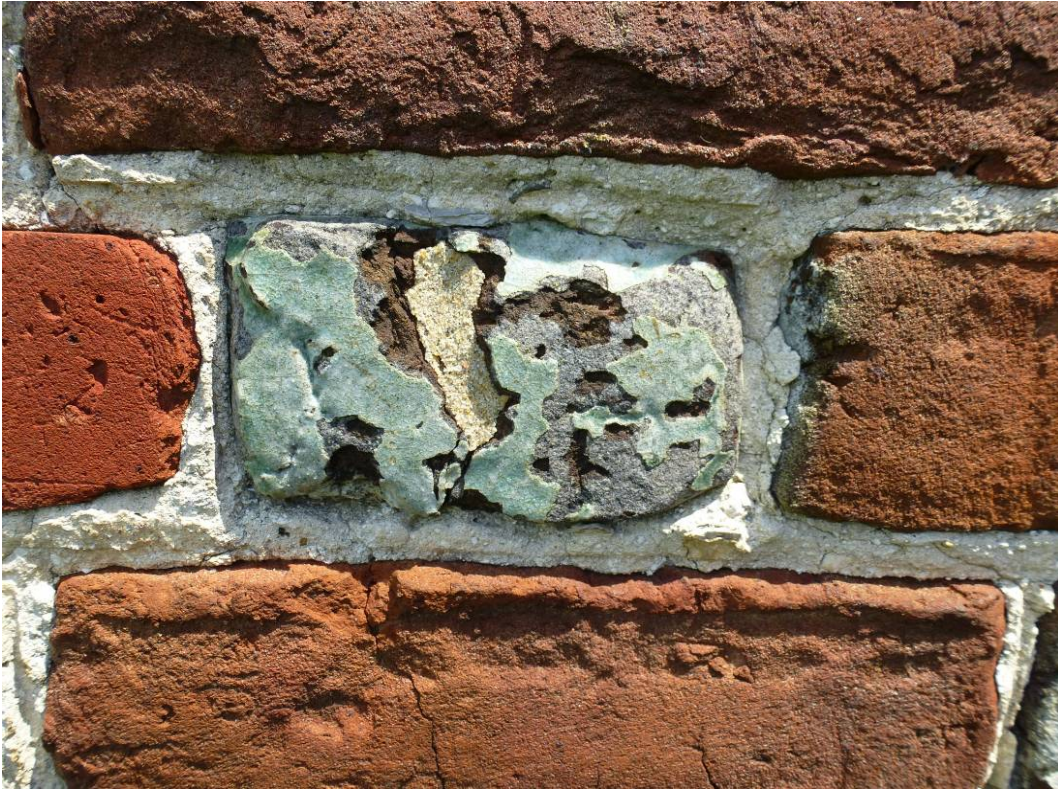
Figure 61. Improper repair of glazed header brick (ERDC-CERL, 2012).

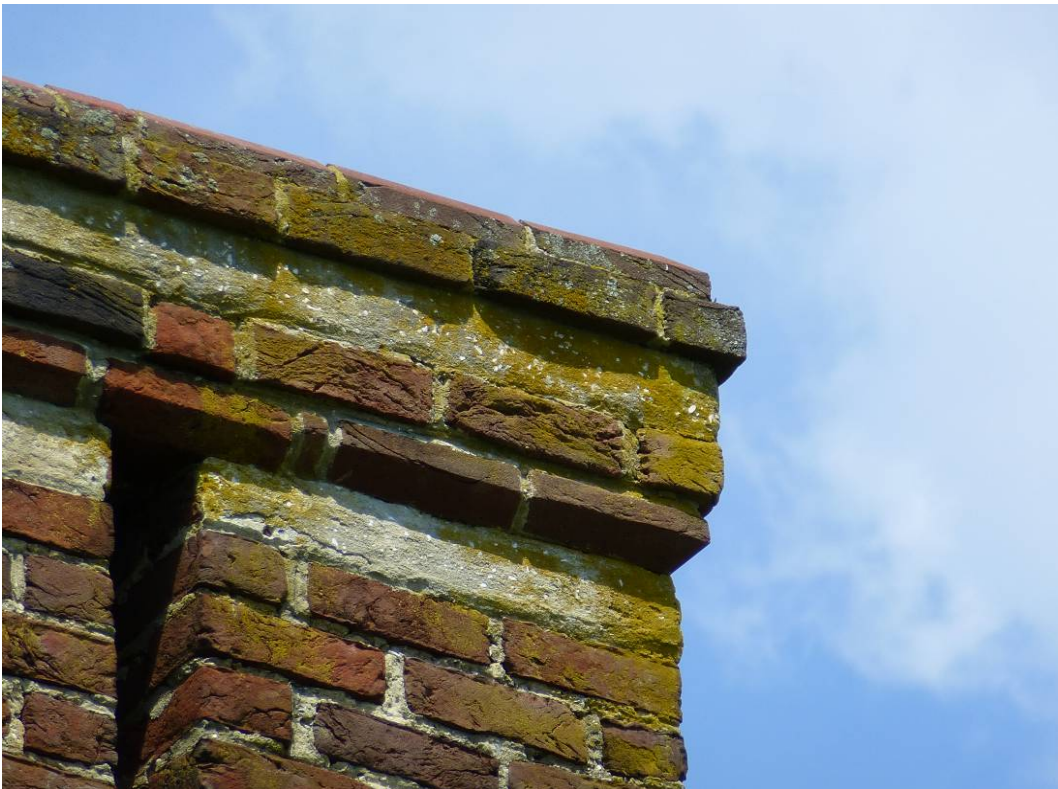
Figure 73. Growth/stains on the top of the chimney brickwork (ERDC-CERL, 2012).

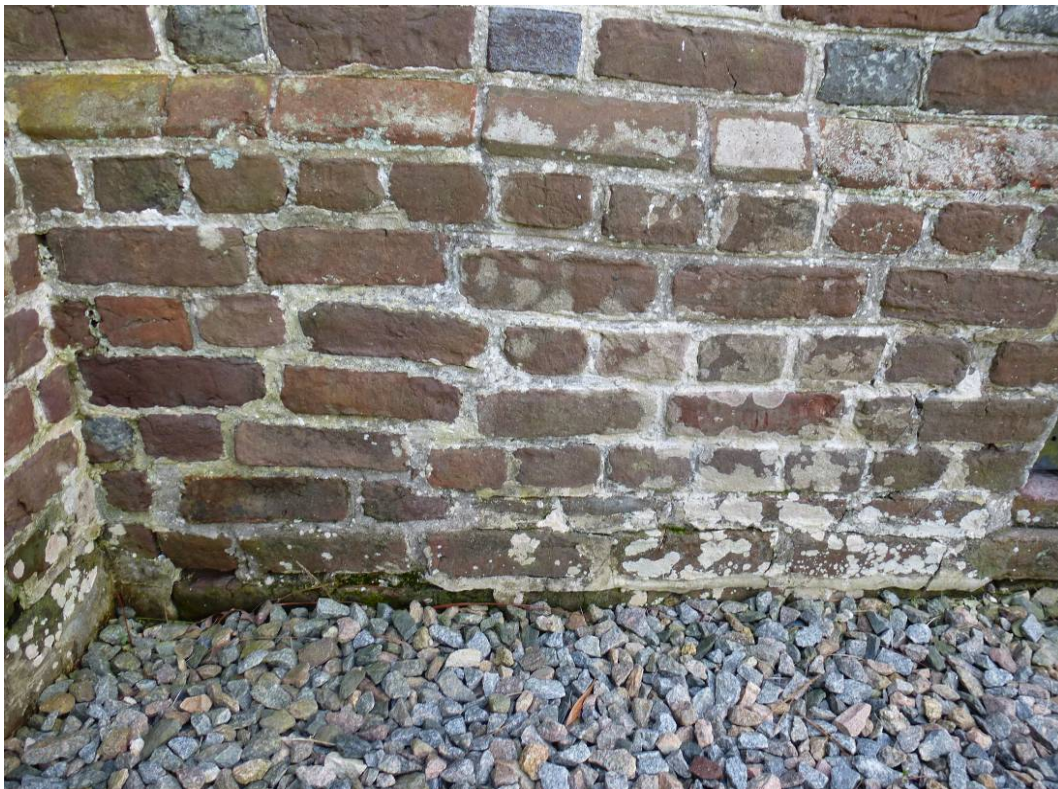
Figure 78. Lichen growth and efflorescence on the water table caused by rain water shedding from roof and splashing back onto the brickwork (ERDC-CERL, 2012).

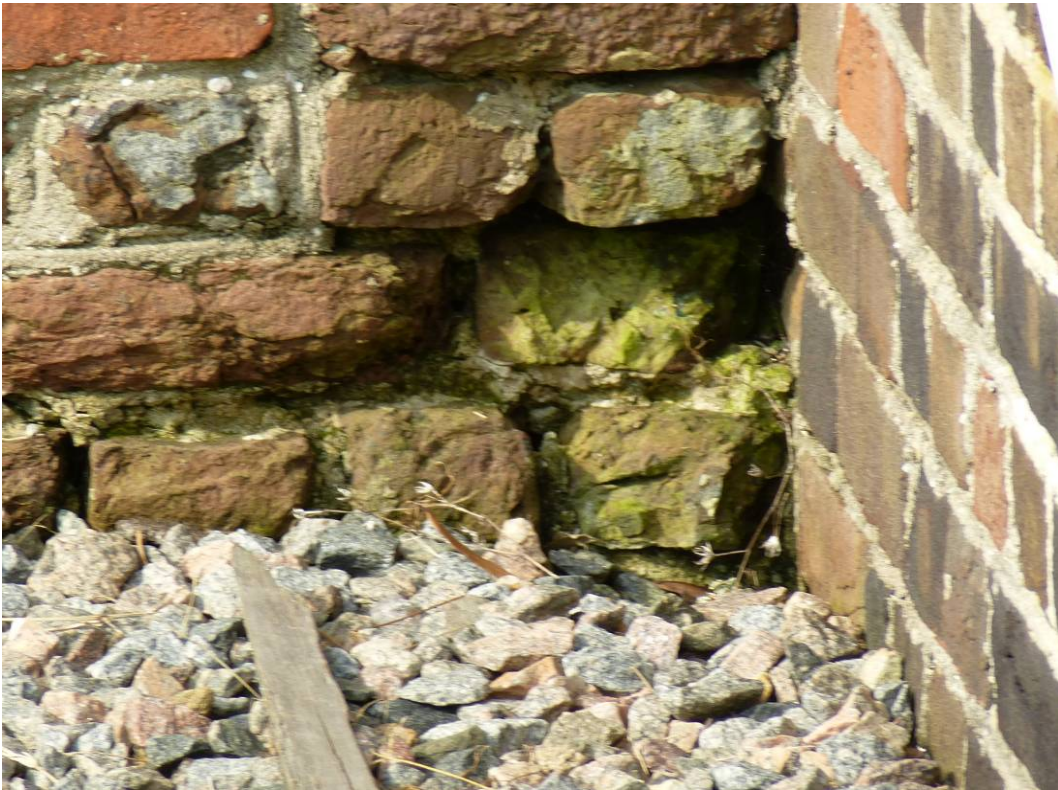
Figure 79. Deteriorated brick caused by the water that splashes off of the large gravel. This type of deterioration is called erosion (ERDC-CERL, 2012).

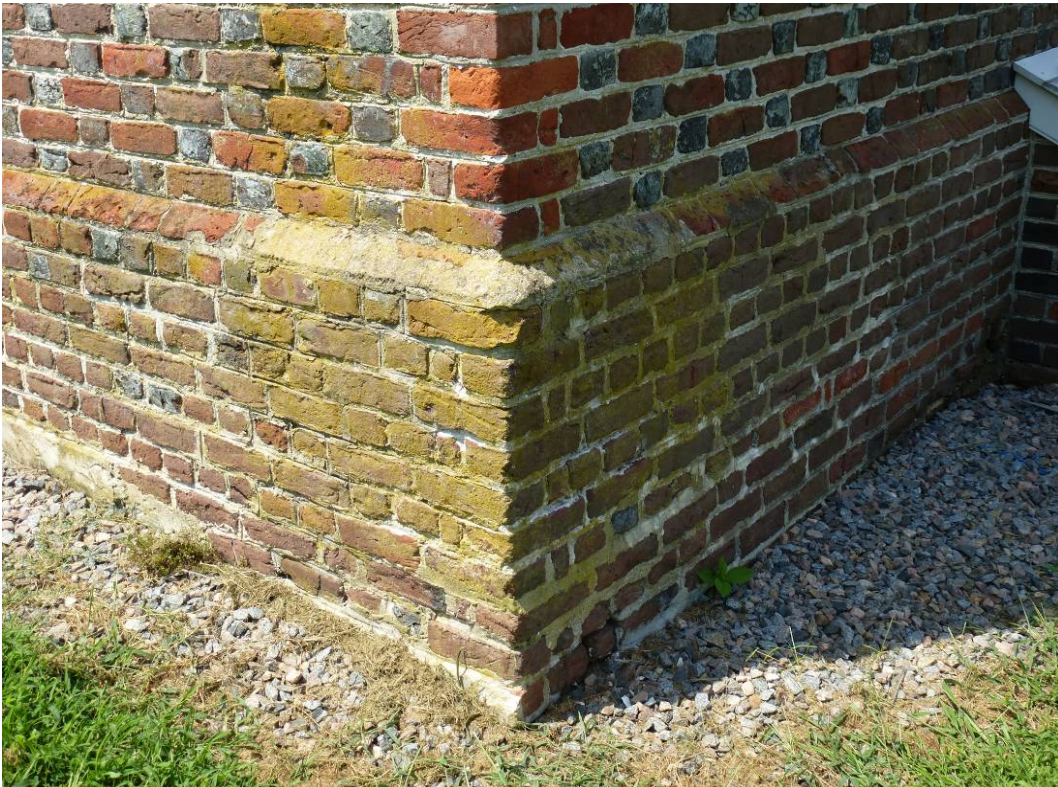
Figure 80. Stains and growth on the water table (ERDC-CERL, 2012).

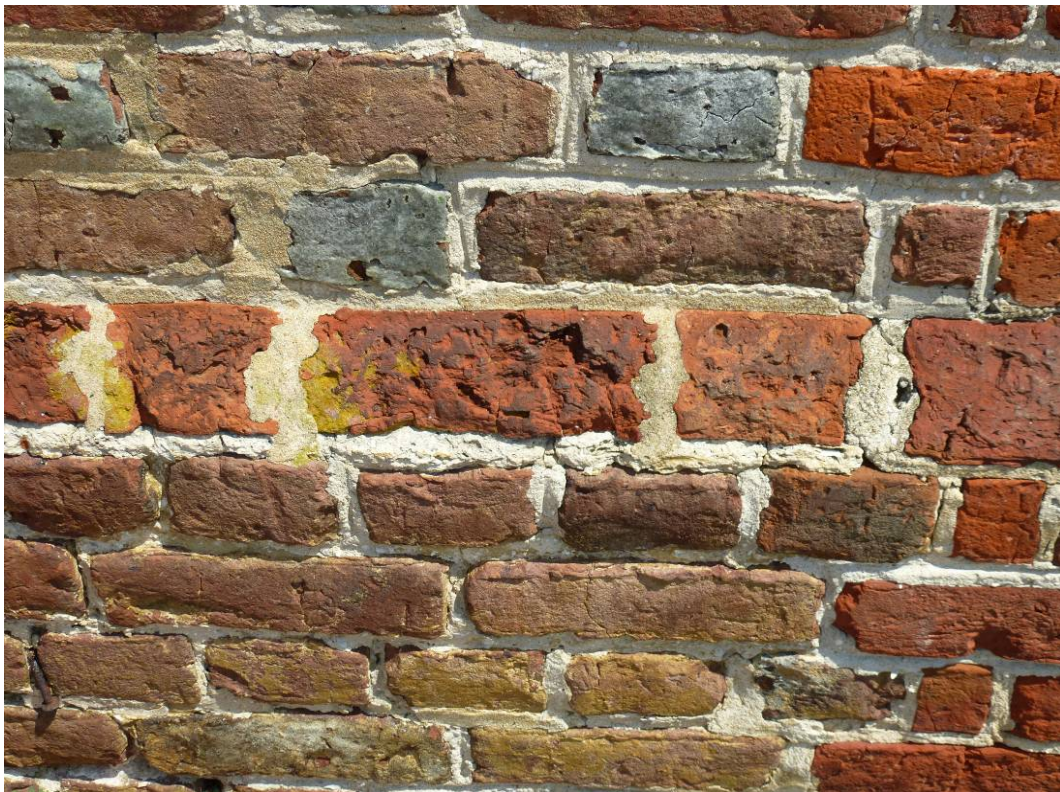
Figure 81. Bricks on the top layer of the water table are showing signs of deterioration called pitting (ERDC-CERL, 2012).

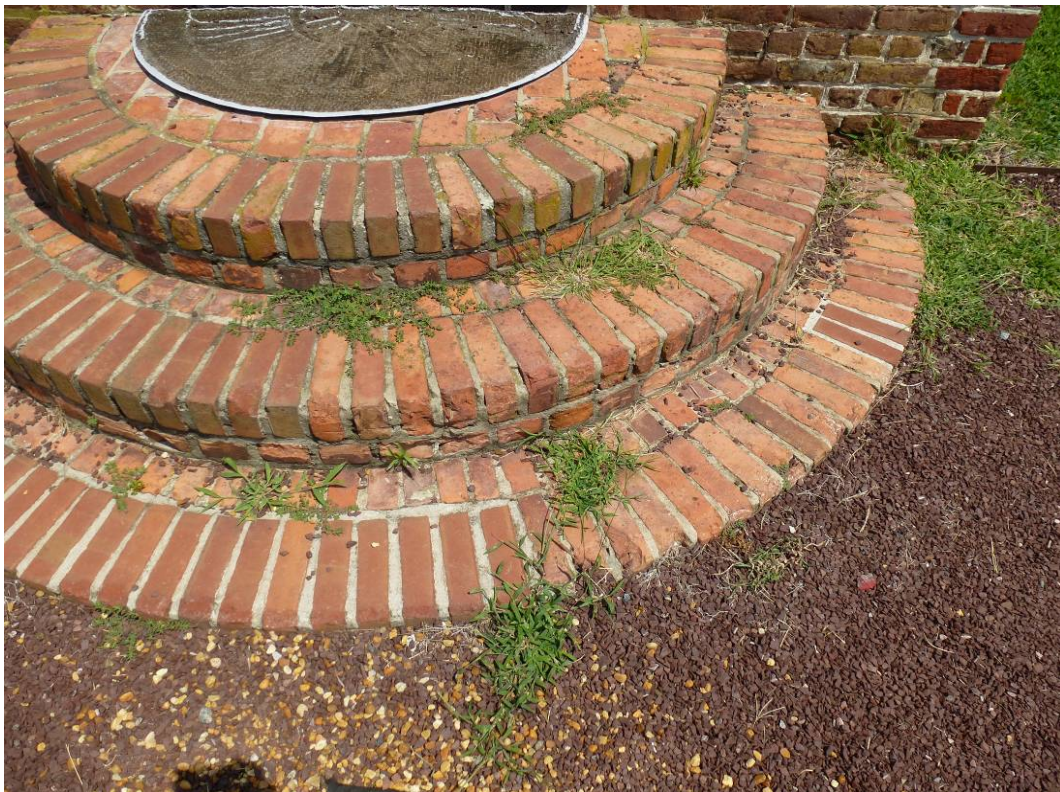
Figure 86. Semicircular design of front steps showing vegetation growth (ERDC-CERL, 2012).

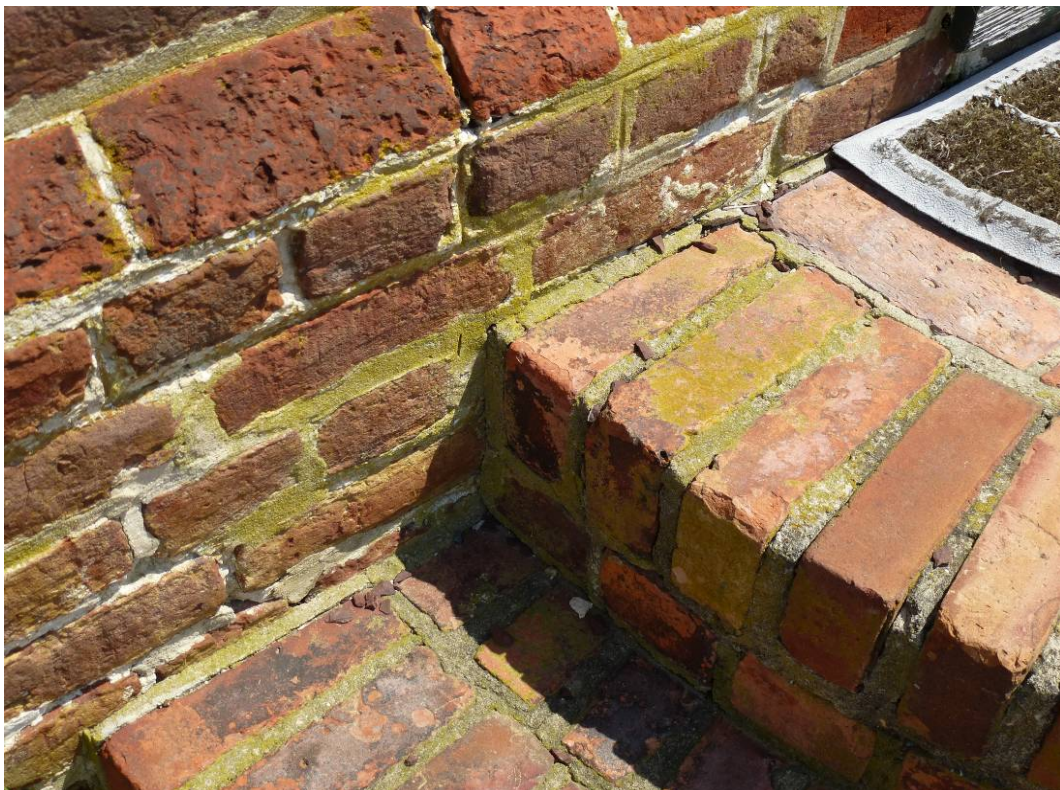
Figure 87. Growth and stains on front steps from rain water (ERDC-CERL, 2012).

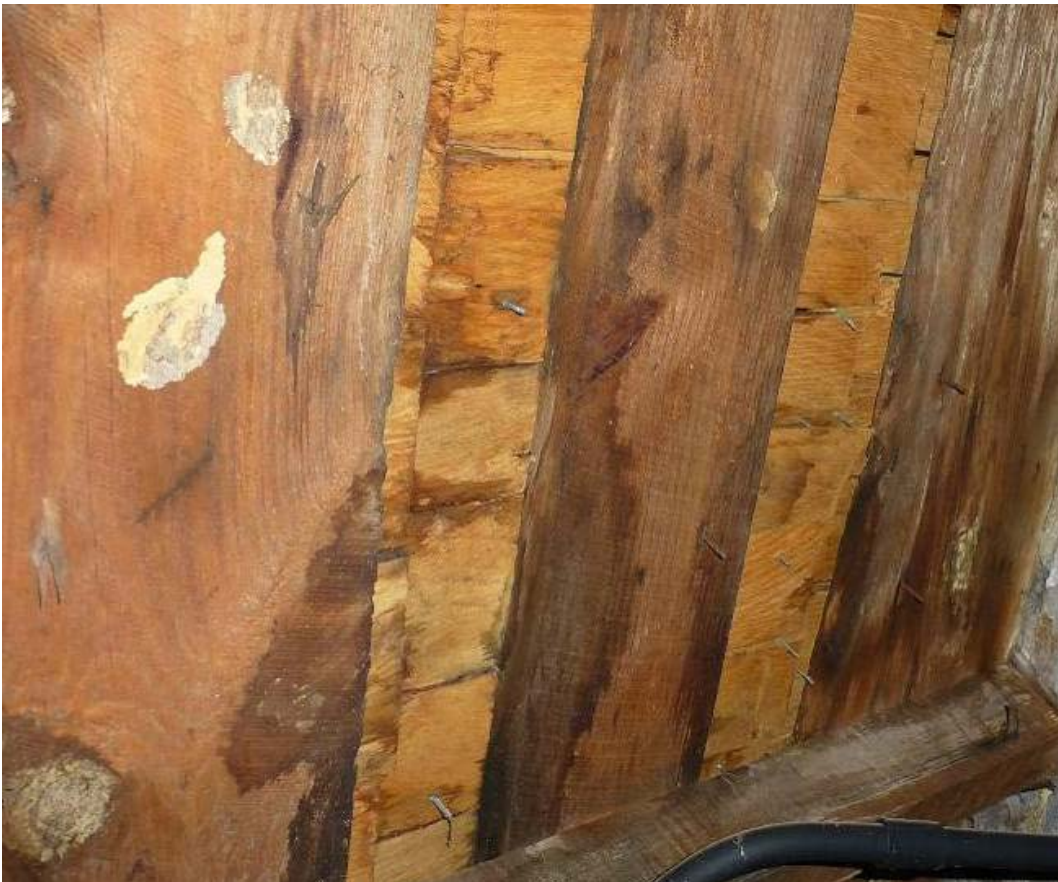
Figure 96. Underside of the wood shingles showing protruding nails and wet roofing members (ERDC-CERL, 2012).

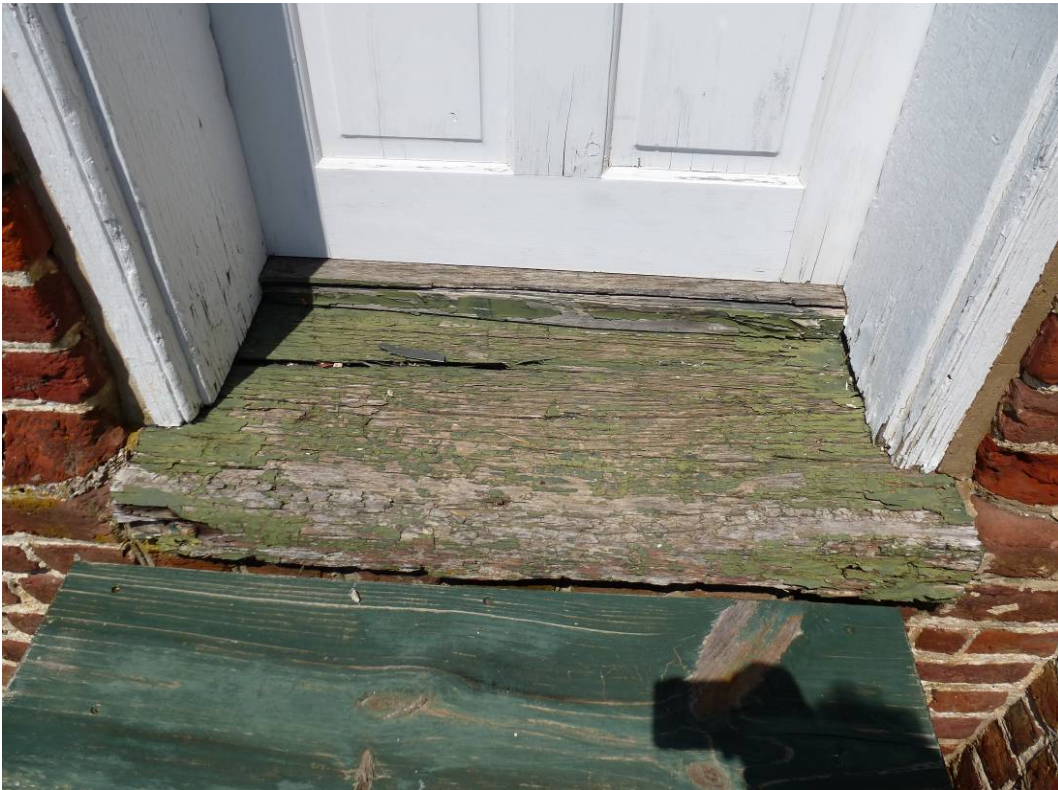
Figure 105. Deteriorated wood threshold for the side door is too damaged for repair and needs to be replaced (ERDC-CERL, 2012).

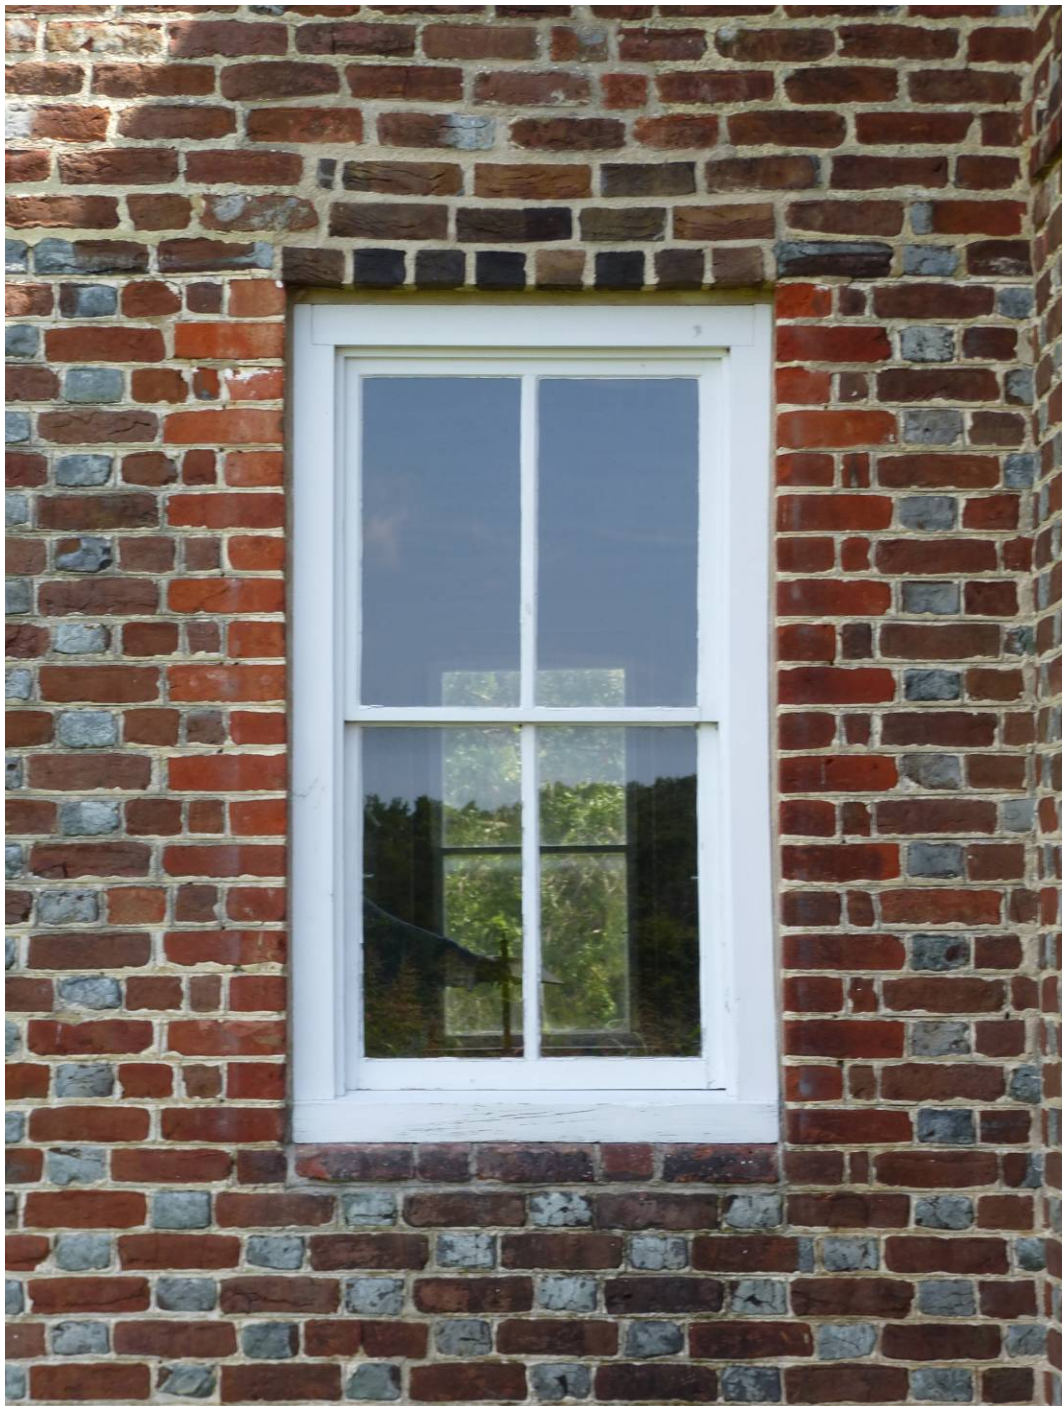
Figure 112. First-floor Period III window that needs to be replaced with an accurate Period II window (ERDC-CERL, 2012).

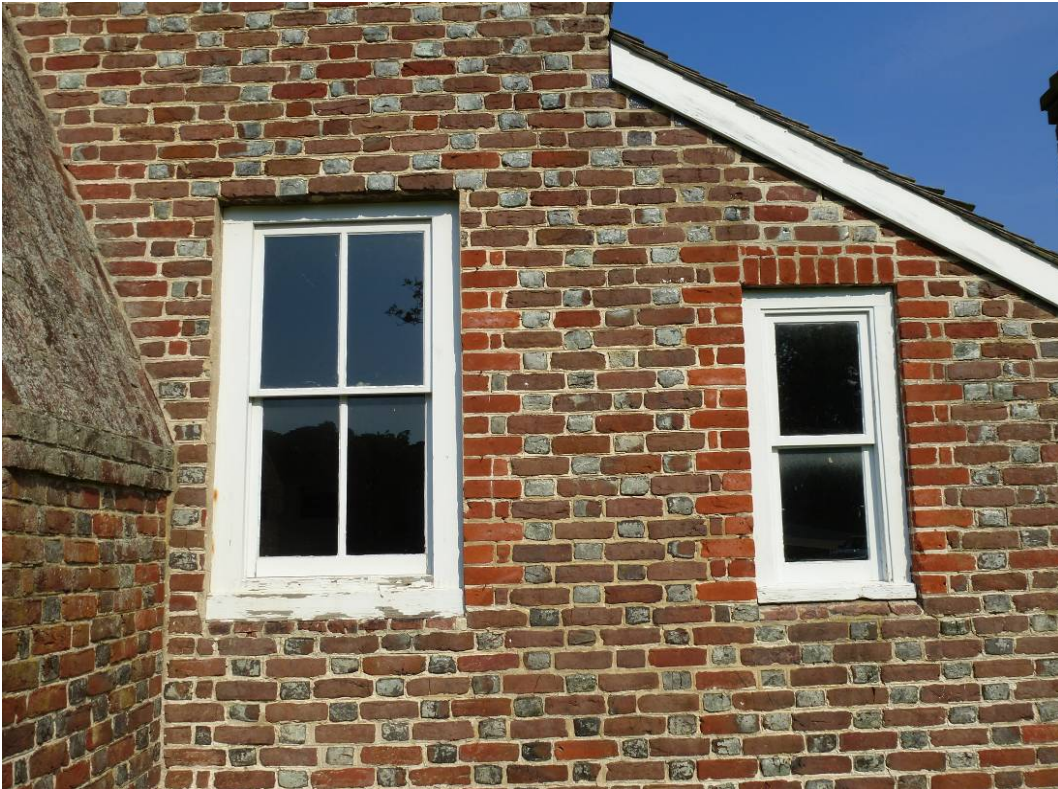
Figure 113. A two-over-two wood window on the main block and a one-over-one wood window on the southeast elevation of the shed room (rear chamber) addition that need to be replaced with an accurate Period II windows (ERDC-CERL, 2012).

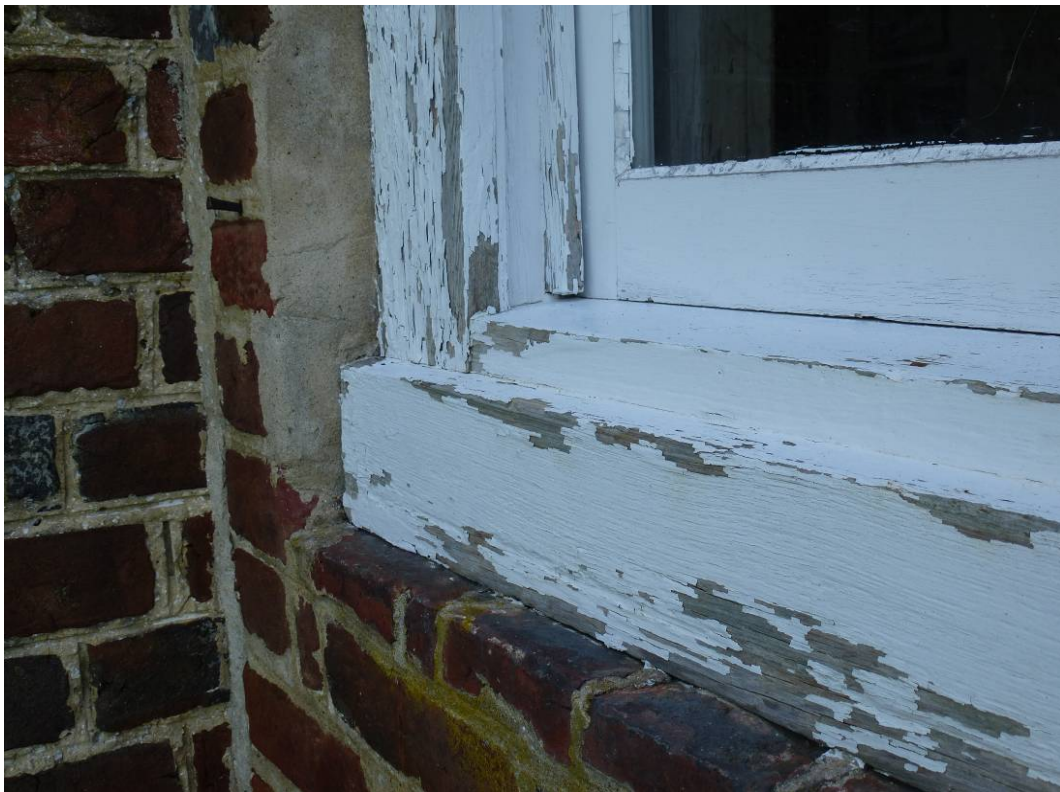
Figure 115. Deterioration of paint on wood window frame and sash (ERDC-CERL, 2012).

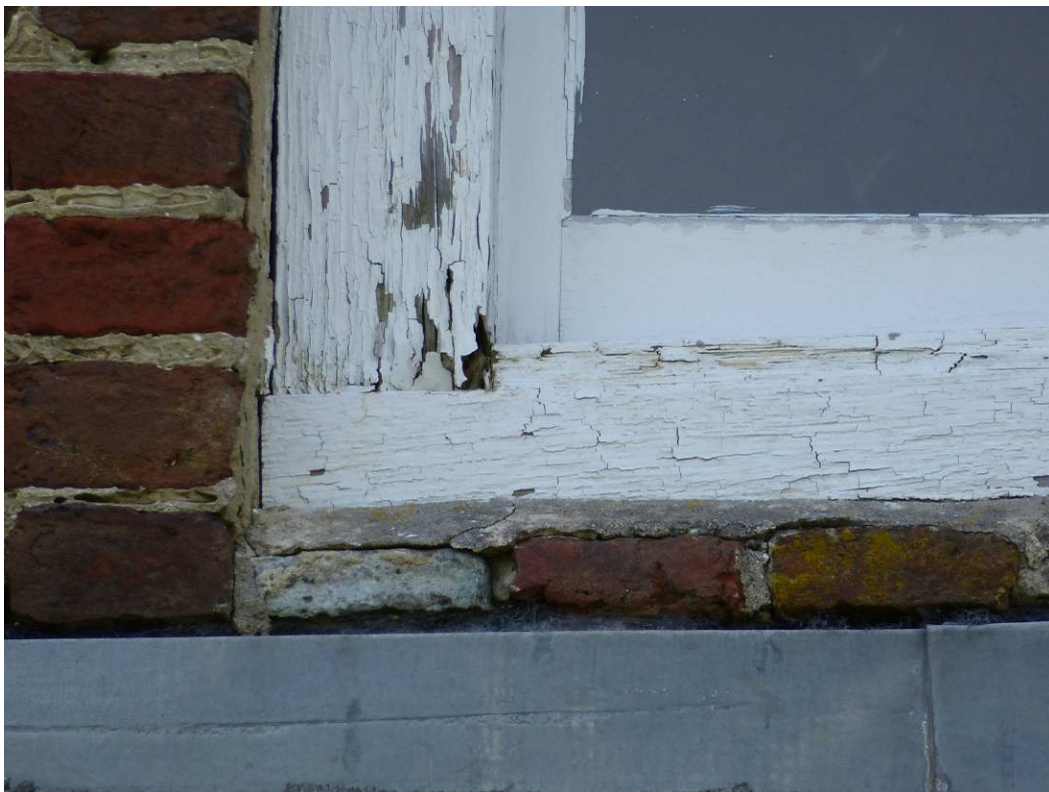
Figure 116. Detail of a damaged wood window frame (ERDC-CERL, 2012).
